# Experiences on Assessment and Retrofitting of Reinforced Concrete Buildings with Masonry Infill in Kathmandu Valley

15 WCEE  
LISBOA 2012

**M.R. Tamrakar, H. Shrestha & R. Guragain**

*National Society for Earthquake Technology-Nepal (NSET), Lalitpur, Nepal*

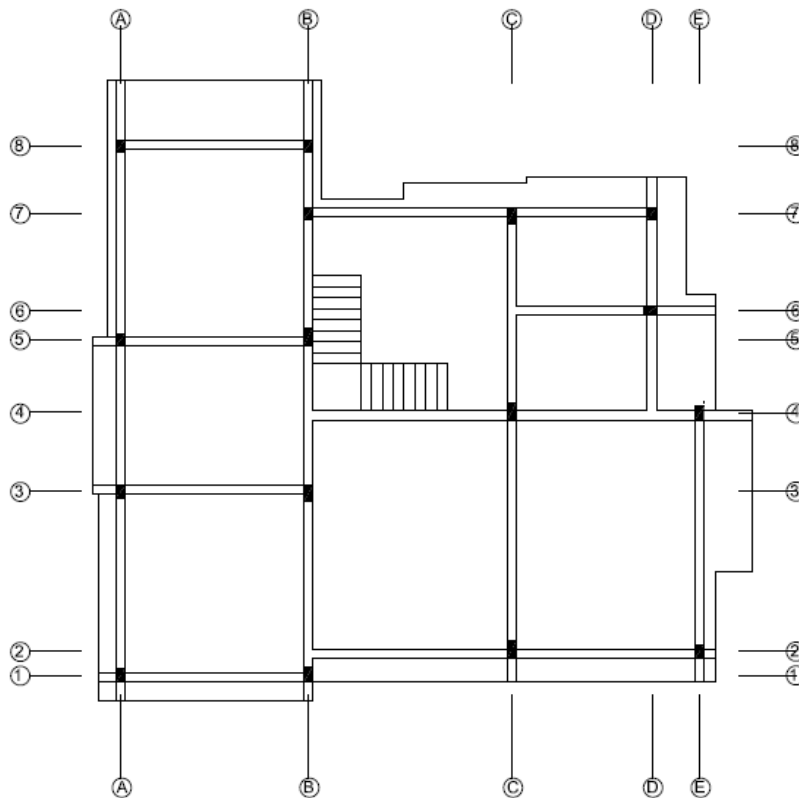
**Figure 1.** Plan of the building showing the structural grids

It is a three storey reinforced concrete frame building with masonry infill walls. The building is located in northern side of the Kathmandu Metropolitan city. This is a newly constructed engineered building. The plan is square in shape, however, the structural system is irregular. There are in total 16 numbers of columns. Sizes of columns varies from 225 mm X 300 mm to 225 mm X 450 mm. External periphery walls are constructed of full brick thickness (225 mm) and internal walls are either half brick thick (115 mm) or full brick thick (230 mm). The floor plans showing structural grids is shown in figure 1.

- (1) There are three complete moment resisting frames in north-south direction whereas no complete moment resisting frames in east-west direction. This created load path discontinuity.
- (2) All columns except D6 are oriented length in north-south direction. This creates larger stiffness in north-south direction only.
- (3) Walls on the external periphery of the building are not placed on the frame centreline and are projected outwards. This also leads to load path discontinuity in the building.
- (4) Spacing of ties in columns varies from 100 mm c/c to 150 mm c/c. This leads to non ductile detailing of reinforcements.
- (5) There is a lack of wall to frame connection leading to possibility of out of plane collapse of walls.

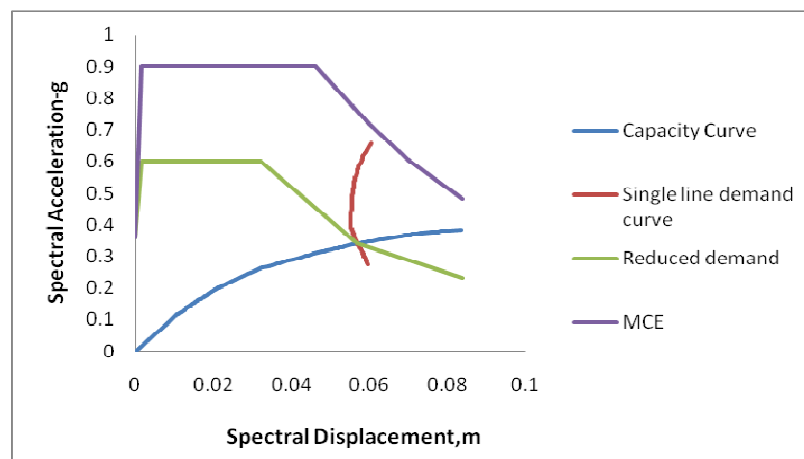
Figure 2. Results of pushover analysis along north-south direction

Pushover analysis along north-south direction illustrated that performance point exist at spectral acceleration of 0.34g and spectral displacement of 57 mm at 16.9 % effective damping (see figure 2). However, performance point does not exist in east-west direction, implying that the structure does not have adequate lateral strength and stiffness in this direction (see figure 3). Therefore, the building needs to be retrofitted to enhance the performance of the building.

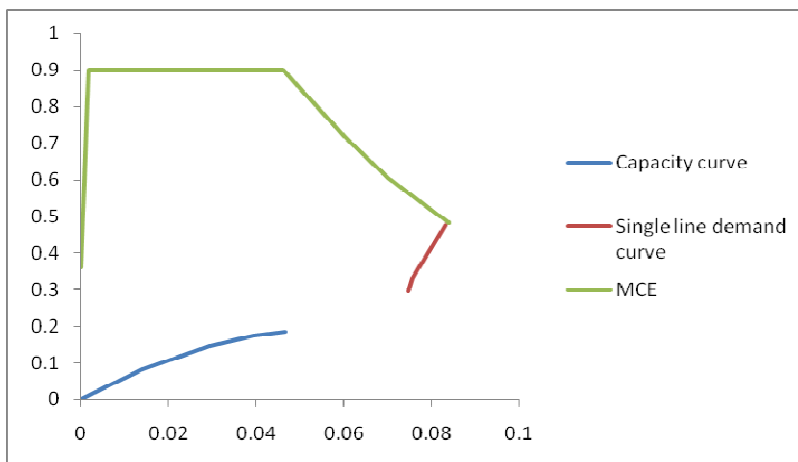
**Figure 3.** Results of pushover analysis along east-west direction

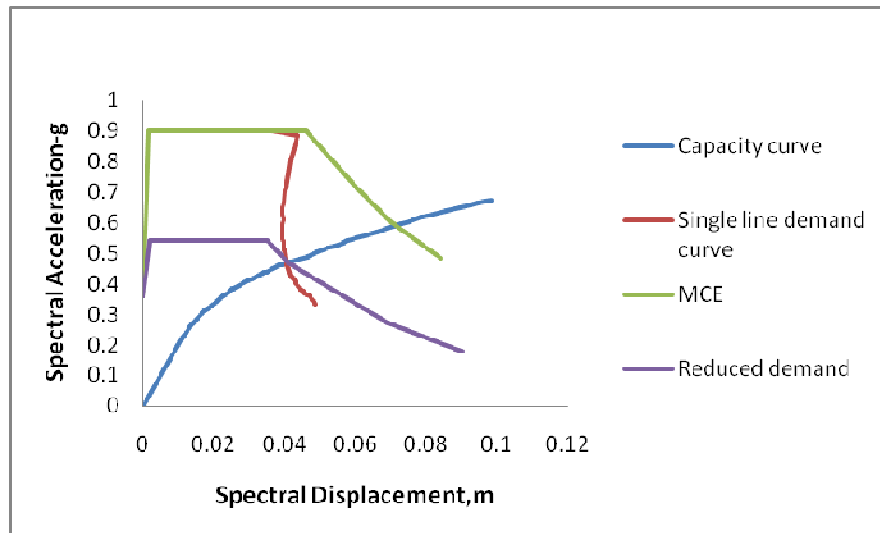
**Figure 5.** Results of pushover analysis of retrofitted building along north-south direction

Pushover analysis along north-south direction of the retrofitted building illustrated that performance point exist at spectral acceleration of 0.47g and spectral displacement of 41 mm at 17.3 % effective damping (see figure 5). Similarly, Pushover analysis along east-west direction of the retrofitted building illustrated that performance point exist at spectral acceleration of 0.38g and spectral displacement of 51 mm at 16.7 % effective damping (see figure 6).

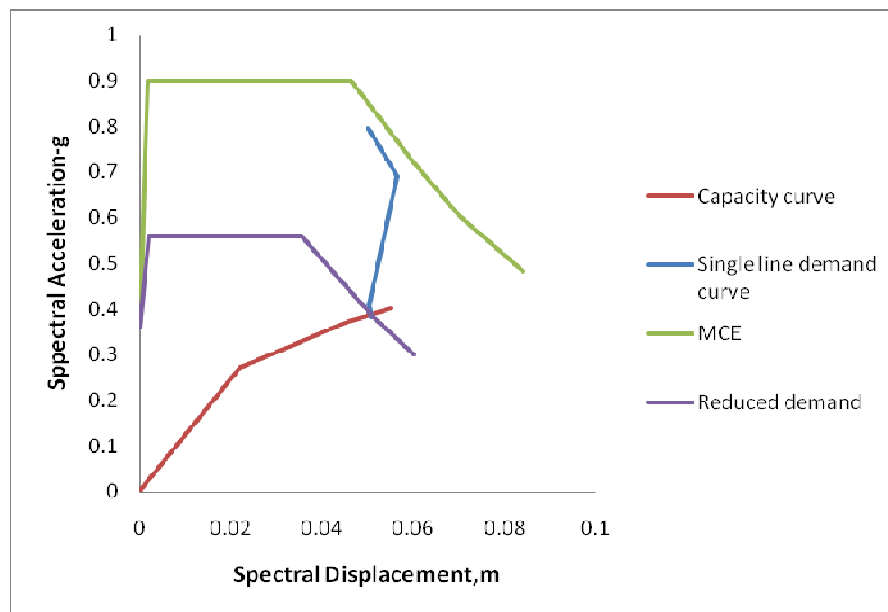
**Figure 6.** Results of pushover analysis of retrofitted building along east-west direction
